Register of Hazardous Materials Report

Redfern Courthouse & Police Station
103-105 Redfern Street
REDFERN NSW 2016

Report Date: 17.07.2006
Project Reference: ENVISYDN00900AA

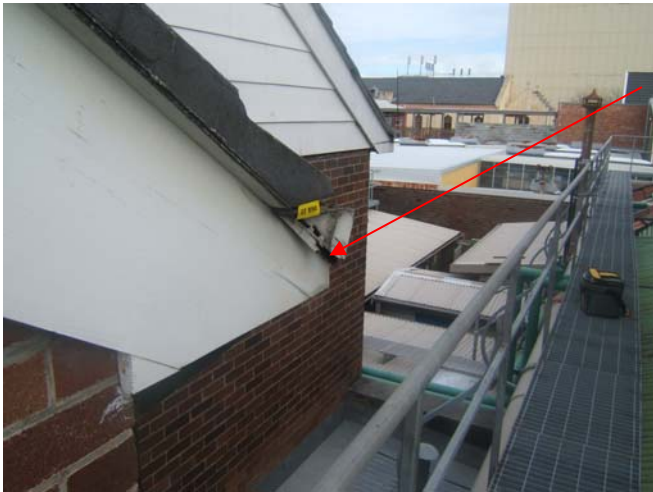
Photograph 1: Roof lining beneath roof tiles located North elevation, lower gable roof.

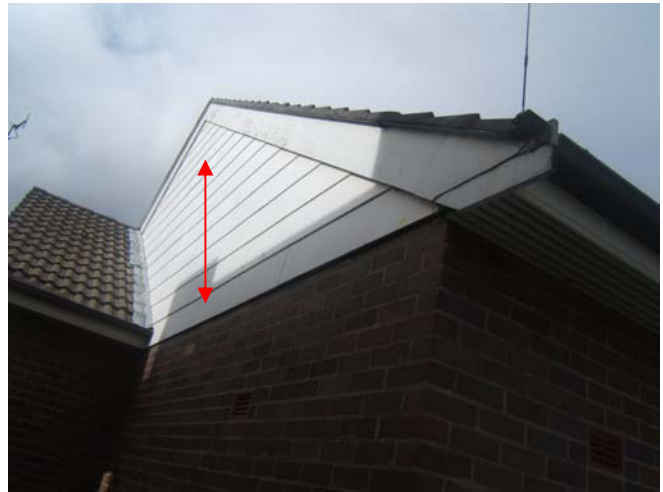
Photograph 2: Gable lining located at upper gable roof located on North Elevation.

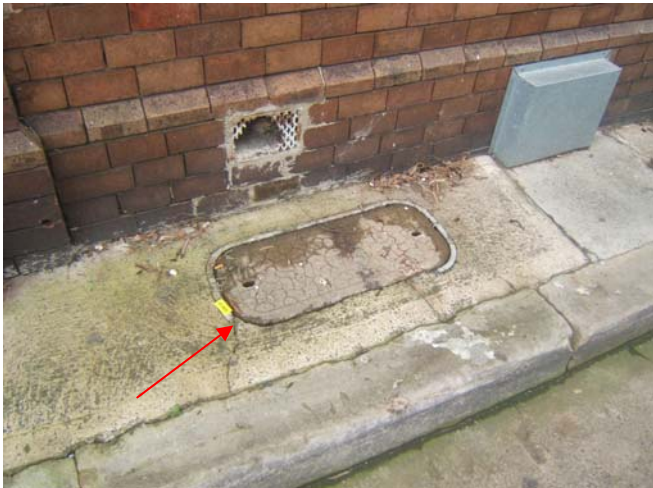
Photograph 3: Moulded fibre cement cable pit within ground, located near front entrance.

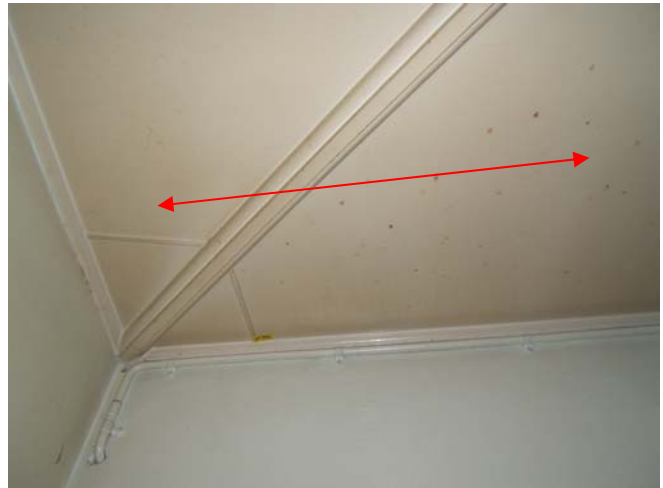
Photograph 4: Eaves lining surrounding the courtyard area.

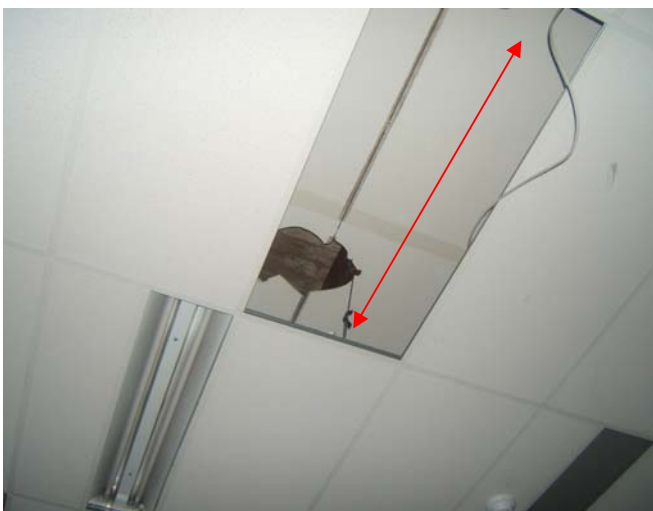
Photograph 5: Ceiling above suspended ceiling within "small exhibits" room.

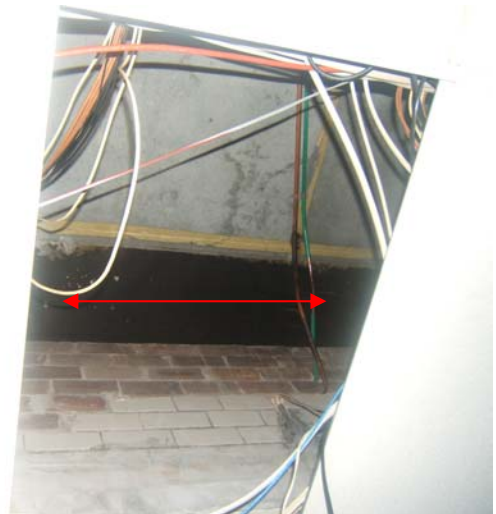
Photograph 6: Waterproof membrane on east side only of ground floor within ceiling space.

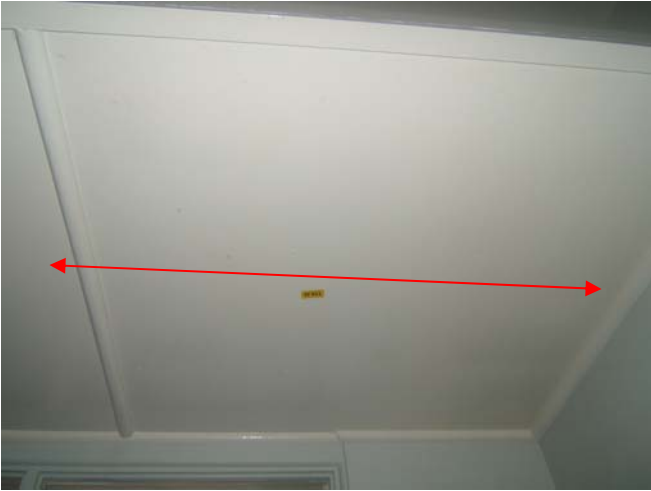
Photograph 7: Ceiling lining in the Men's Amenities located on first floor.

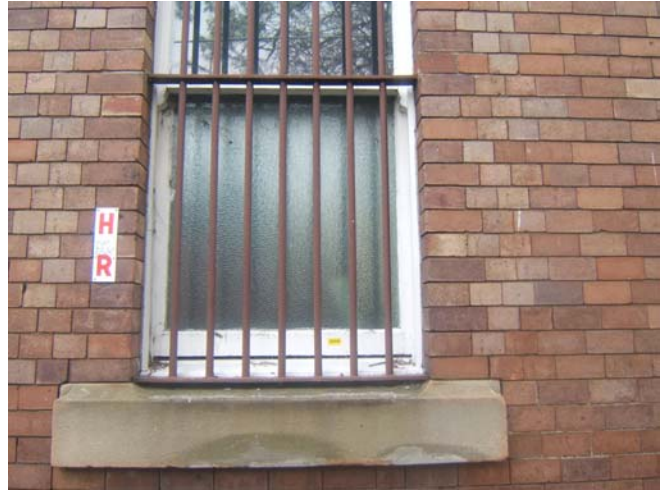
Photograph 8: White paint work to the window frames located on south elevations.

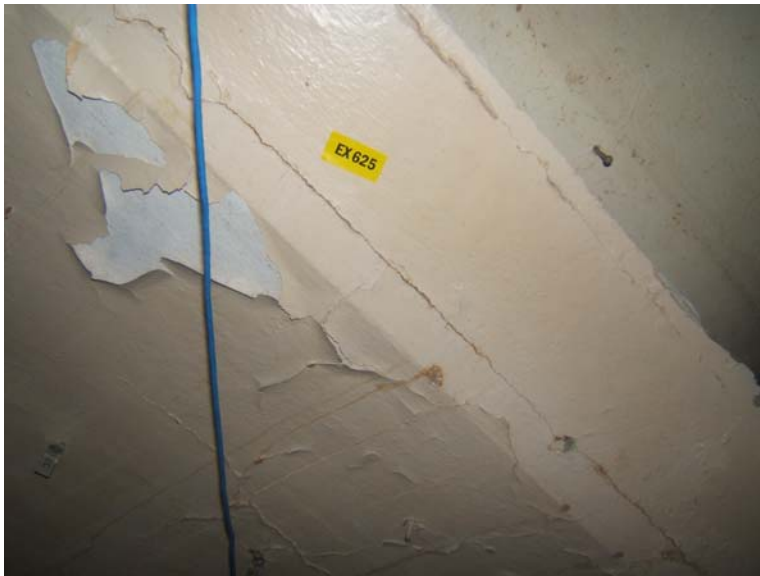
Photograph 9: Cream paint work to the ceiling located in "Interview & Breath Analysis" room, above suspended ceiling tiles.

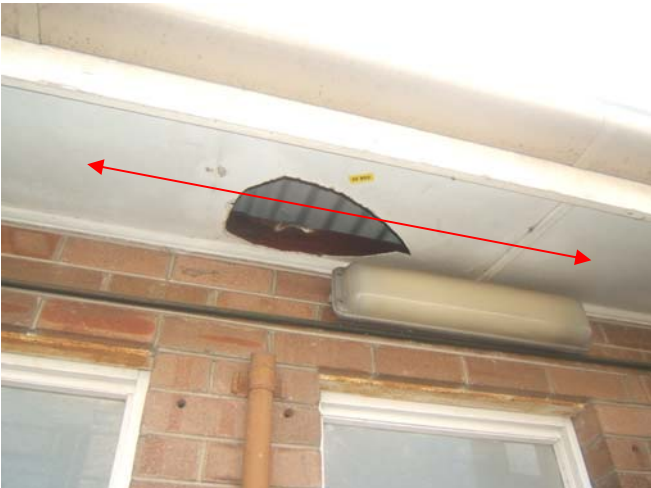
Photograph 10: Eaves lining located South elevation of "Magistrates chamber" room's

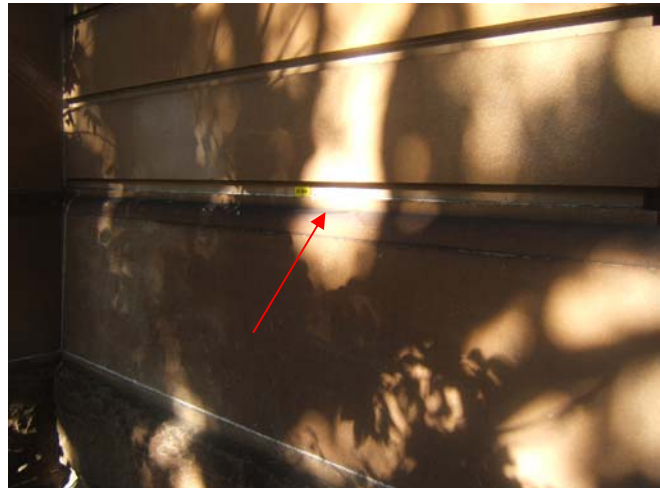
Photograph 11: External Sealant (white) between brick work predominantly on North elevation.

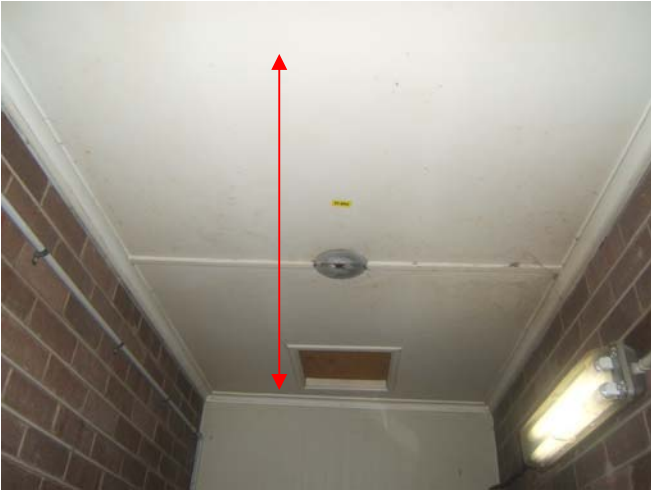
Photograph 12: Ceiling lining located between "male staff" & "records room".

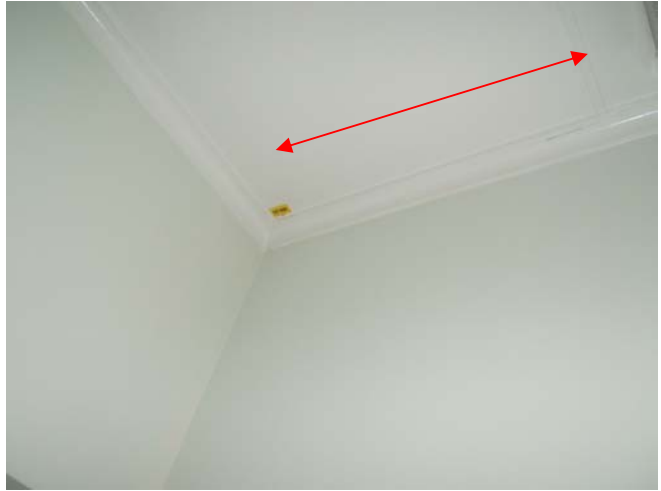
Photograph 13: Ceiling lining located internal "Female staff", toilet section.

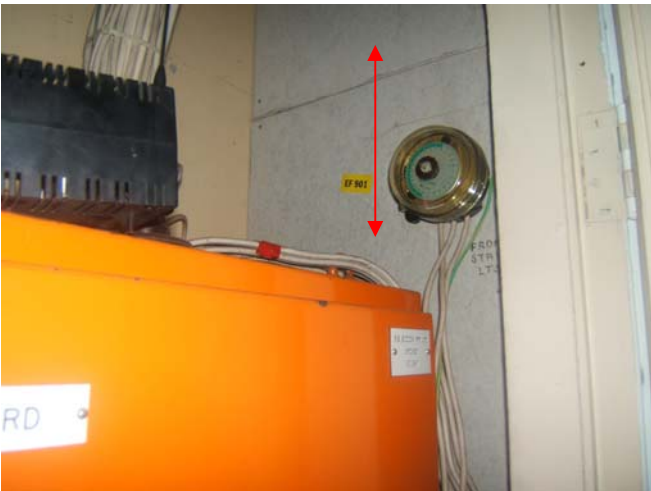
Photograph 14: Fibre Cement Sheet wall lining within Electrical cupboard.

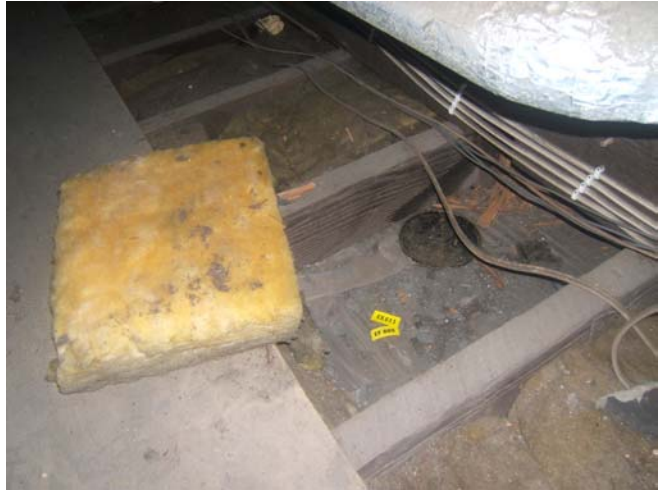
Photograph 15: SMF dust on ceiling within western and eastern wing of the courthouse.

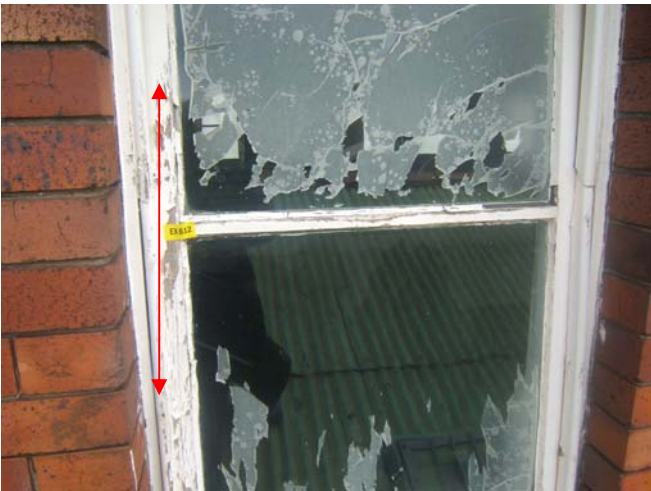
Photograph 16: External paint work to window frames located along perimeter of courtroom.

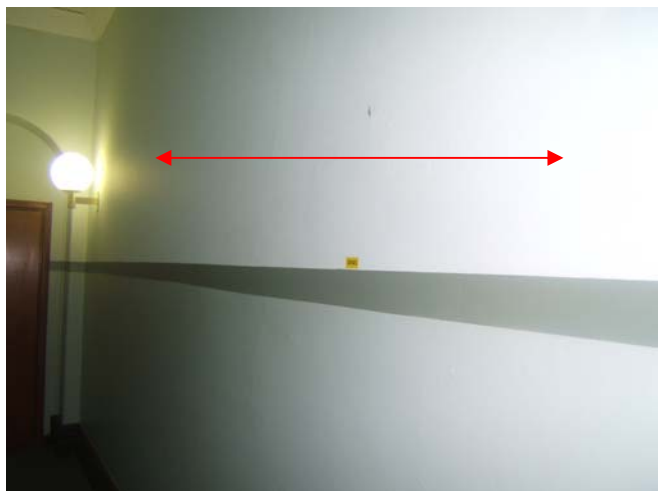
Photograph 17: Internal paint work to walls throughout corridors of main courthouse building.

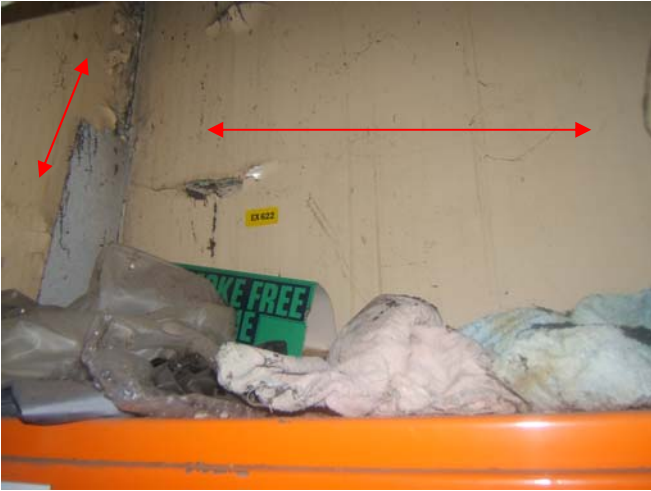
Photograph 18: Internal paint work to walls within electrical cupboard.

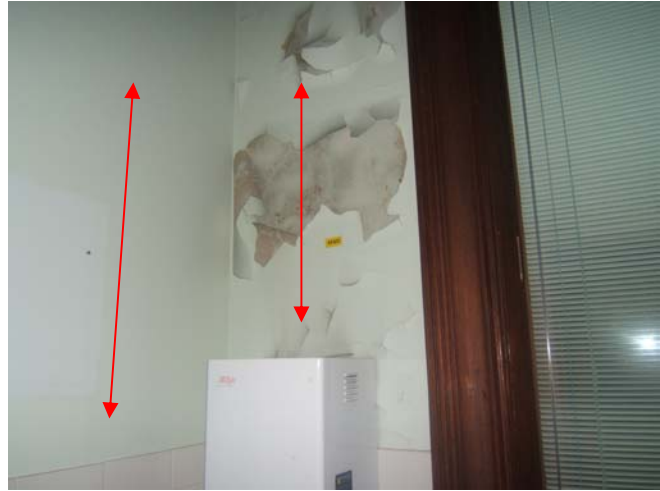
Photograph 19: Internal paint work to walls in DV room.
