**WINTEN PROPERTY GROUP**

**PROPOSED RESIDENTIAL SUBDIVISION DEVELOPMENT  
MARSDEN PARK PRECINCT – NORTH WEST GROWTH CENTRE  
RICHMOND ROAD, MARSDEN PARK**

**LAND CAPABILITY, SALINITY AND CONTAMINATION ASSESSMENTS  
REPORT**

**REPORT NO 12576/1-AA**

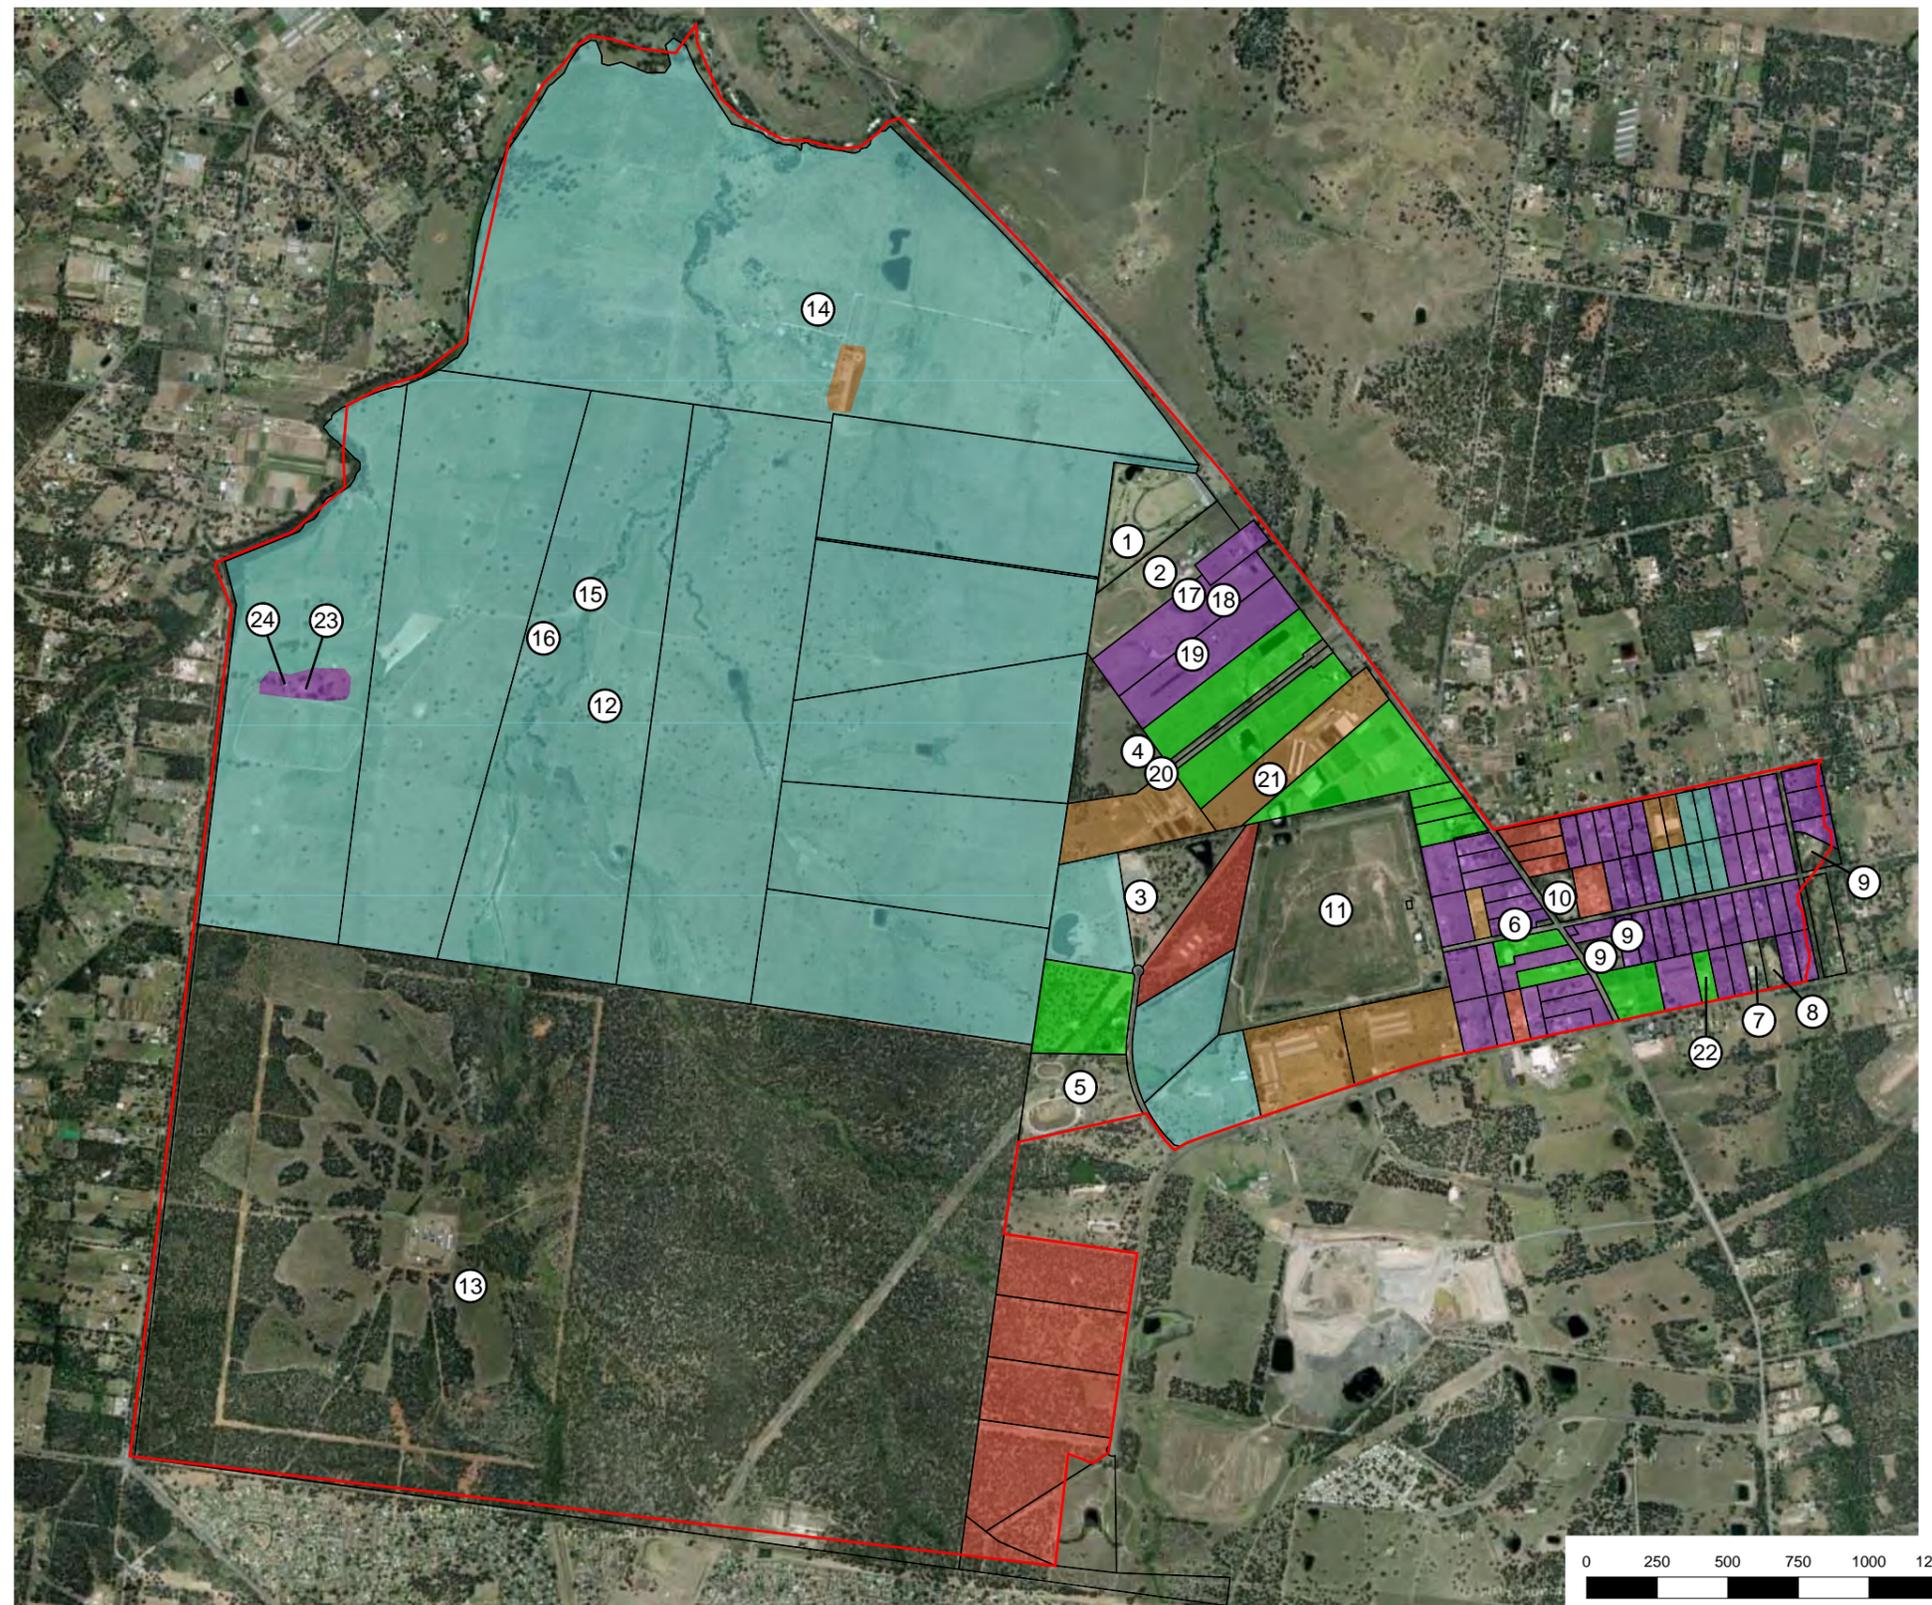
- Fill materials observed in the site, including illegal dumping in Lot 10 in DP70287, could be contaminated.
- Chicken carcasses might have been buried in the poultry farms (Site Feature 21, see Drawing No 12576/1-AA1).

- Blacktown City Council depot is located in the eastern portion of the site close to Richmond Road.
- Other site features noted within the site are highlighted on the Site Features Drawing 12576/1-AA1. These features are mainly fill and suspected fill areas, scattered mostly in the eastern portion of the site. In particular, above ground diesel and petroleum storage tanks and a disused fuel dispenser (bowser) from a former underground petroleum storage tank, marked as features 24 and 25 respectively in the above drawing.
