**PROPOSED RESIDENTIAL SUBDIVISION DEVELOPMENT
MARSDEN PARK PRECINCT – NORTH WEST GROWTH CENTRE
RICHMOND ROAD, MARSDEN PARK**

**LAND CAPABILITY, SALINITY AND CONTAMINATION ASSESSMENTS
REPORT**

REPORT NO 12576/1-AA

27 FEBRUARY 2012

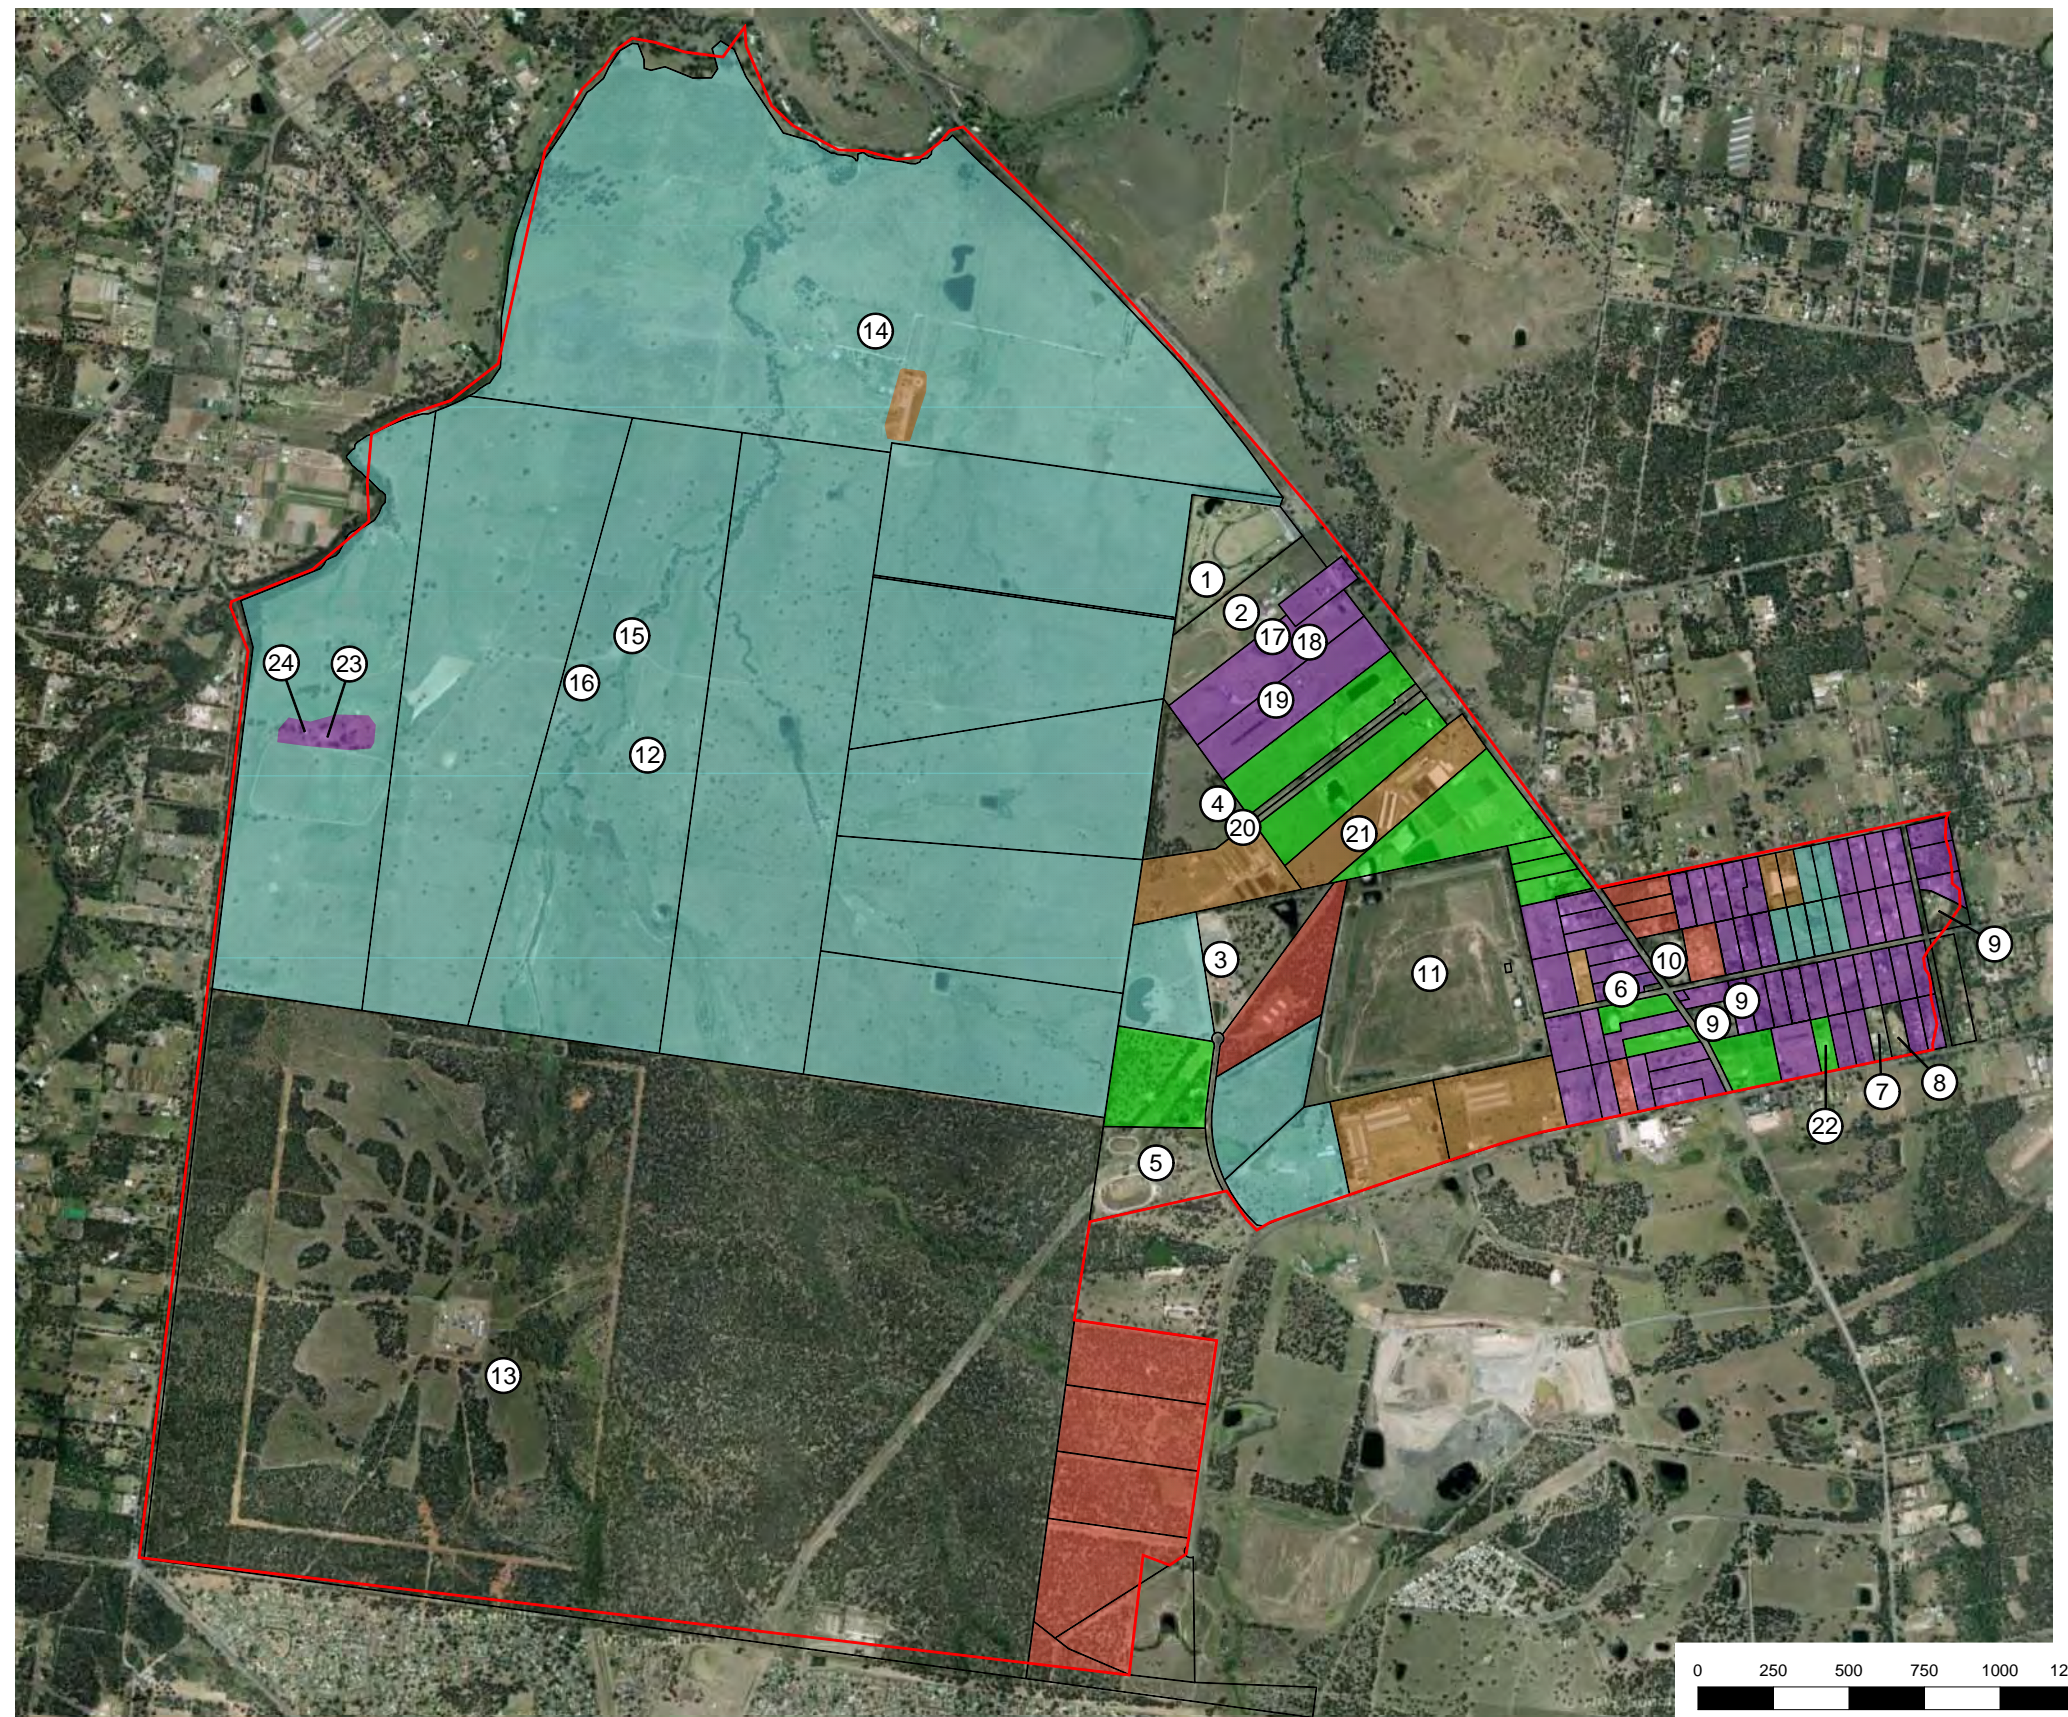
- Fill materials observed in the site, including illegal dumping in Lot 10 in DP70287, could be contaminated.
- Chicken carcasses might have been buried in the poultry farms (Site Feature 21, see Drawing No 12576/1-AA1).

- Blacktown City Council depot is located in the eastern portion of the site close to Richmond Road.
- Other site features noted within the site are highlighted on the Site Features Drawing 12576/1-AA1. These features are mainly fill and suspected fill areas, scattered mostly in the eastern portion of the site. In particular, above ground diesel and petroleum storage tanks and a disused fuel dispenser (bowser) from a former underground petroleum storage tank, marked as features 24 and 25 respectively in the above drawing.
