**LAND CAPABILITY AND CONTAMINATION  
ASSESSMENT**

**TURNER ROAD PRECINCT**

**CATHERINE FIELD AND CURRANS HILL**

**GROWTH CENTRES COMMISSION**

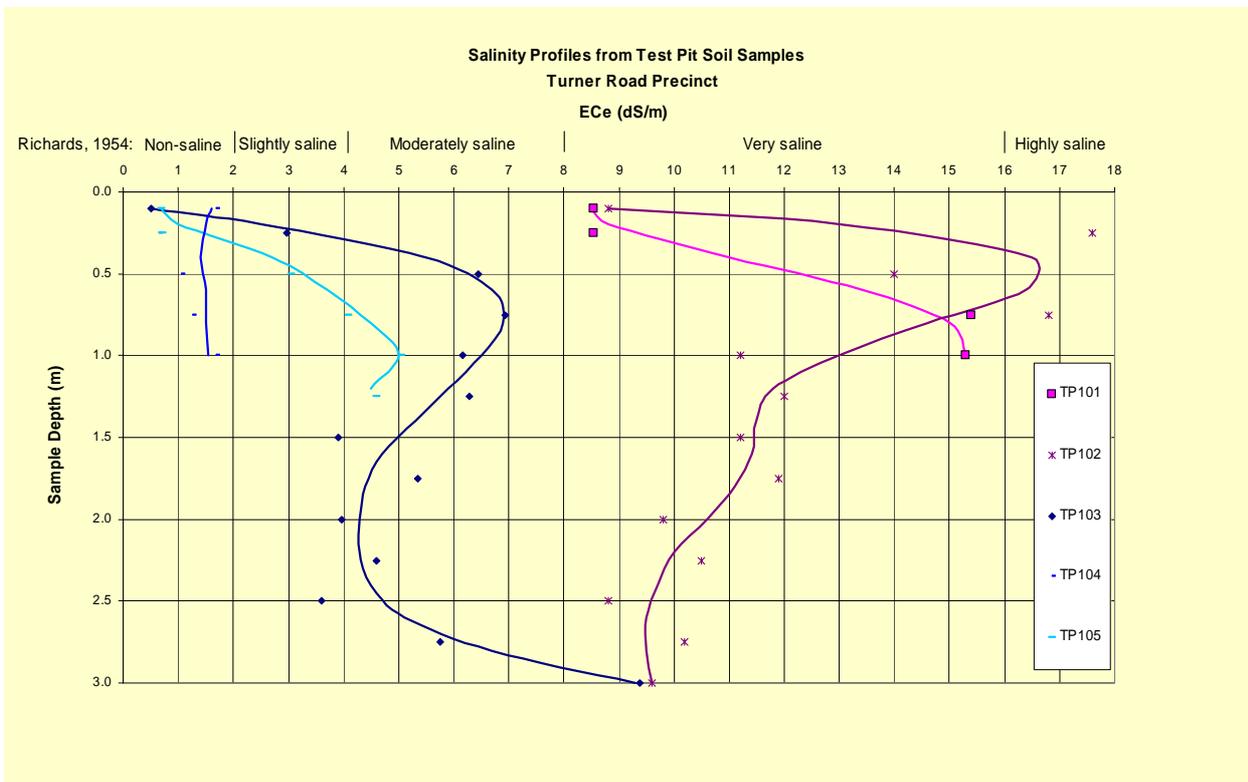
**Figure 1 – Vertical Soil Salinity Profiles**

From these profiles it is inferred that in some areas (e.g. TP 104) soils remain non-saline throughout the tested depth range. At the remaining control test pit locations, salinities generally reach maxima in the 0.5 m to 1 m depth zone, decreasing below 1 m but possibly rising again immediately above rock level. In order to assess the most saline soil horizon, follow-up test pits were sampled for salinity tests at depths of 0.5 m to 0.7 m (23 tests) and 0.9 m to 1.0 m (80 tests). In addition, salinity test results from a depth of 1 m were selected for correlation with EM results (below), since the horizon of maximum salinity (around 1 m) was inferred to have produced the bulk of the EM response.

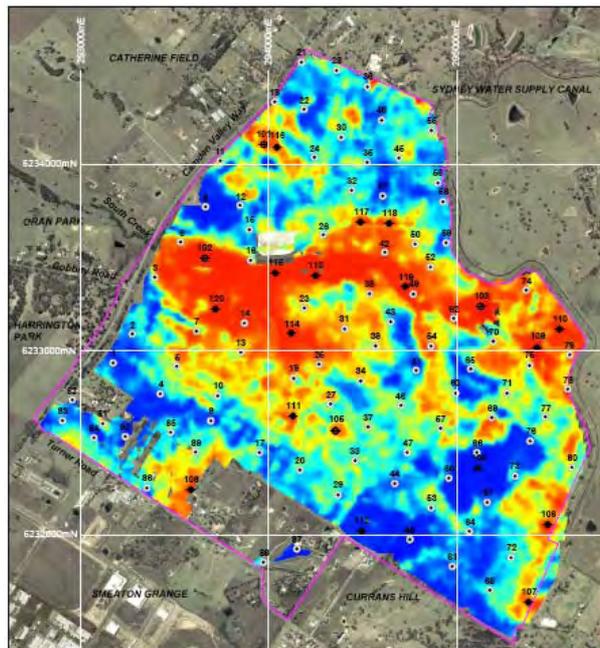
Apparent Conductivity (see Drawing 14, Appendix A)

Apparent conductivity data were added to the GIS database for interpolation onto a regular grid throughout the area surveyed. Drawing 14 (Appendix A and thumbnail image below) presents the apparent conductivity image with a continuous colour spectral scale in mS/m. Areas of most interest are those coloured bright red. Using the classifications of Chhabra (1996, Ref 8), these colours may indicate moderately saline to extremely saline ground conditions.

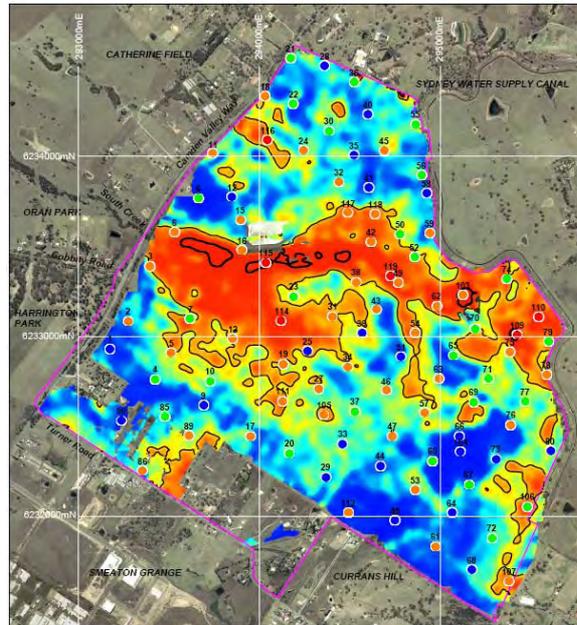
Apparent Salinity (see Drawing 15, Appendix A)

Contours were added to the image in Drawing 15, corresponding to the 4 dS/m and 8 dS/m boundaries of the salinity classes of Richards, providing a direct subdivision of the study area into non-saline and slightly saline classes (<4 dS/m), moderately saline class (4 – 8 dS/m) and very saline class (>8 dS/m). No highly saline areas were inferred.

Areas inferred to be moderately saline or very saline generally occur along the South Creek drainage system but extend into low lying drainage areas and around dams within the golf course north of South Creek and to some areas south of South Creek and close to Turner Road.

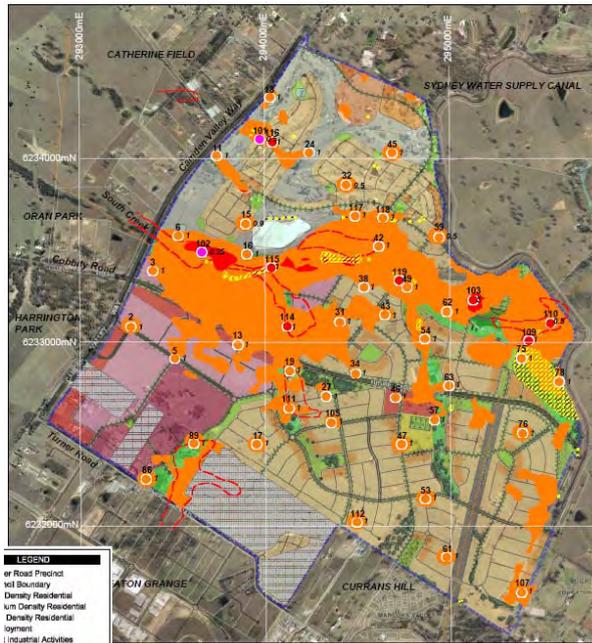
Salinity Constraints (see Appendix A, Drawing 16)

To better assess the constraints that saline soils may place on the proposed development, a number of mappable features were overlain on the aerial photograph of the site to produce a Salinity Constraints map (Drawing 16 Appendix A and thumbnail image below).

- To manage soil from specific building sites or services alignments within the moderate salinity constraint regions or moderate aggressivity constraint regions of Drawings 16 and 18 (Appendix A), use of a bedding layer of sand (say 100 mm minimum) followed by a membrane of thick plastic is recommended under concrete slabs to act as a moisture barrier and drainage layer to restrict capillary rise under the slab.

- Higher than normal strength concrete (say 32MPa) or sulphate resistant cement may need to be considered in very saline constraint regions in order to reduce the risk of reinforcement corrosion in concrete slabs. A minimum of 65 mm of concrete cover on slab reinforcement, proper compaction and curing of concrete are also suggested to produce a dense low permeability concrete.

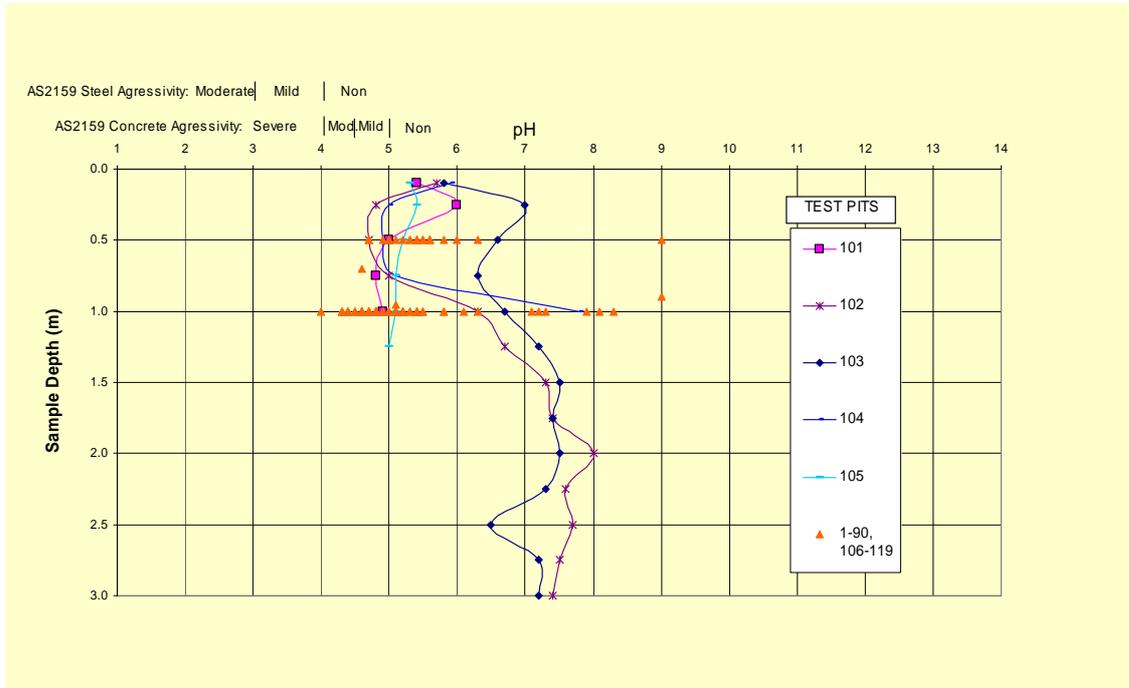
**Figure 4 – pH Profiles**

Aggressivity to concrete varied from non-aggressive to moderately aggressive as indicated by the pH profiles and scattergram of Figure 4, with a tendency for greatest aggressivity in the 0.25 m to 1.0 m depth range.

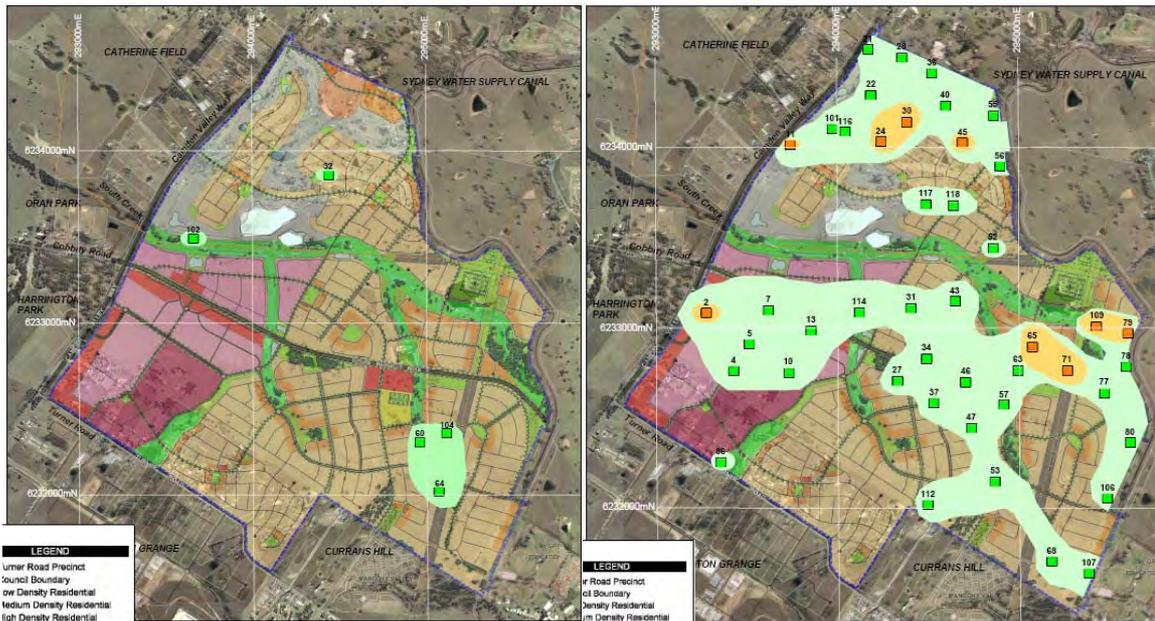
L & R: Aggressivity to concrete at 0.5m and 1m depths (See Drawings 17 and 18, Appendix A)

Drawings 17 and 18 (Appendix A and thumbnail images below) show the lateral distributions of aggressivity to concrete at depths of 0.5 m and 1 m respectively. Because of the number and widespread distribution of test pits from which aggressivity classifications were made, approximate boundaries of mildly aggressive and moderately aggressive zones could not be inferred, so that these drawings do not represent aggressivity constraint maps (discussed in 12.3.4 below).

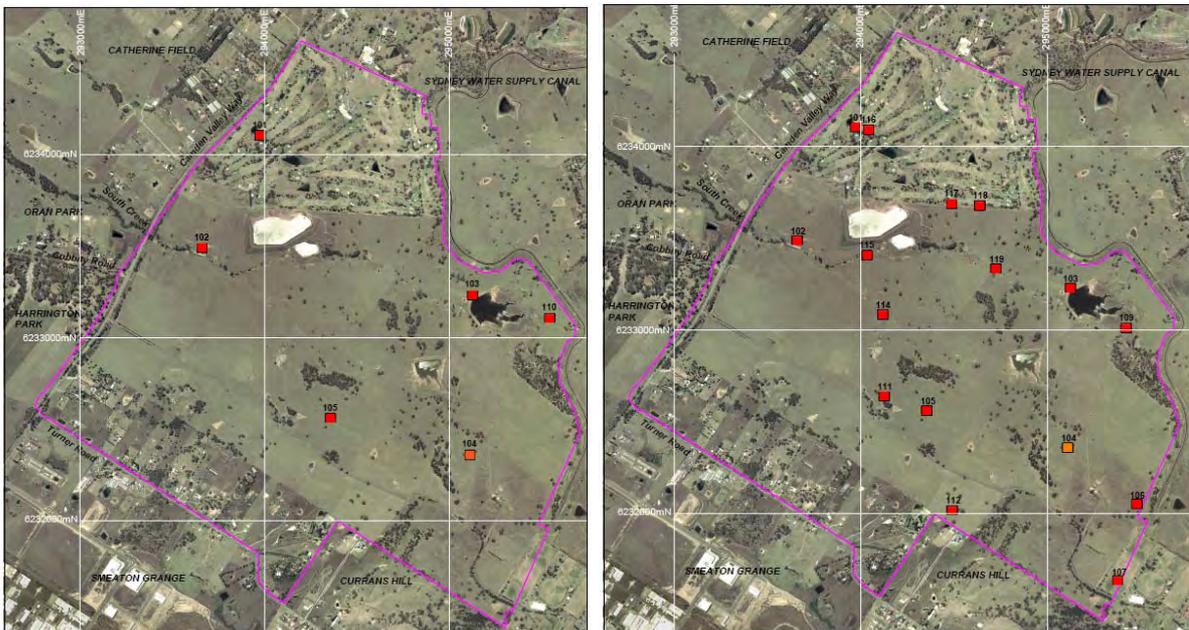
L & R: Sodicity at 0.5m and 1m depths (See Drawings 19 and 20, Appendix A)

Laboratory results and classifications are presented in Table 7a (Appendix J) and indicate highly sodict conditions at both depths in all but one tested location. At Test Pit 104, sodict conditions were indicated at both depths.

Drawings 19 and 20 (Appendix A and thumbnail images below) show the lateral distributions of sodicity at depths of 0.5 m and 1 m respectively. The relatively small number and sparse distribution of test pits from which sodicity measurements were made, prevents the interpretation of detailed sodicity constraint zones. However on the basis of these measurements, it is considered likely that sodic to highly sodic conditions exist throughout the Precinct and that salinity management plans should include strategies for management of this associated property.
