Report for Marsden Park
Industrial Precinct
Phase 2 Contamination
Assessment

May 2009

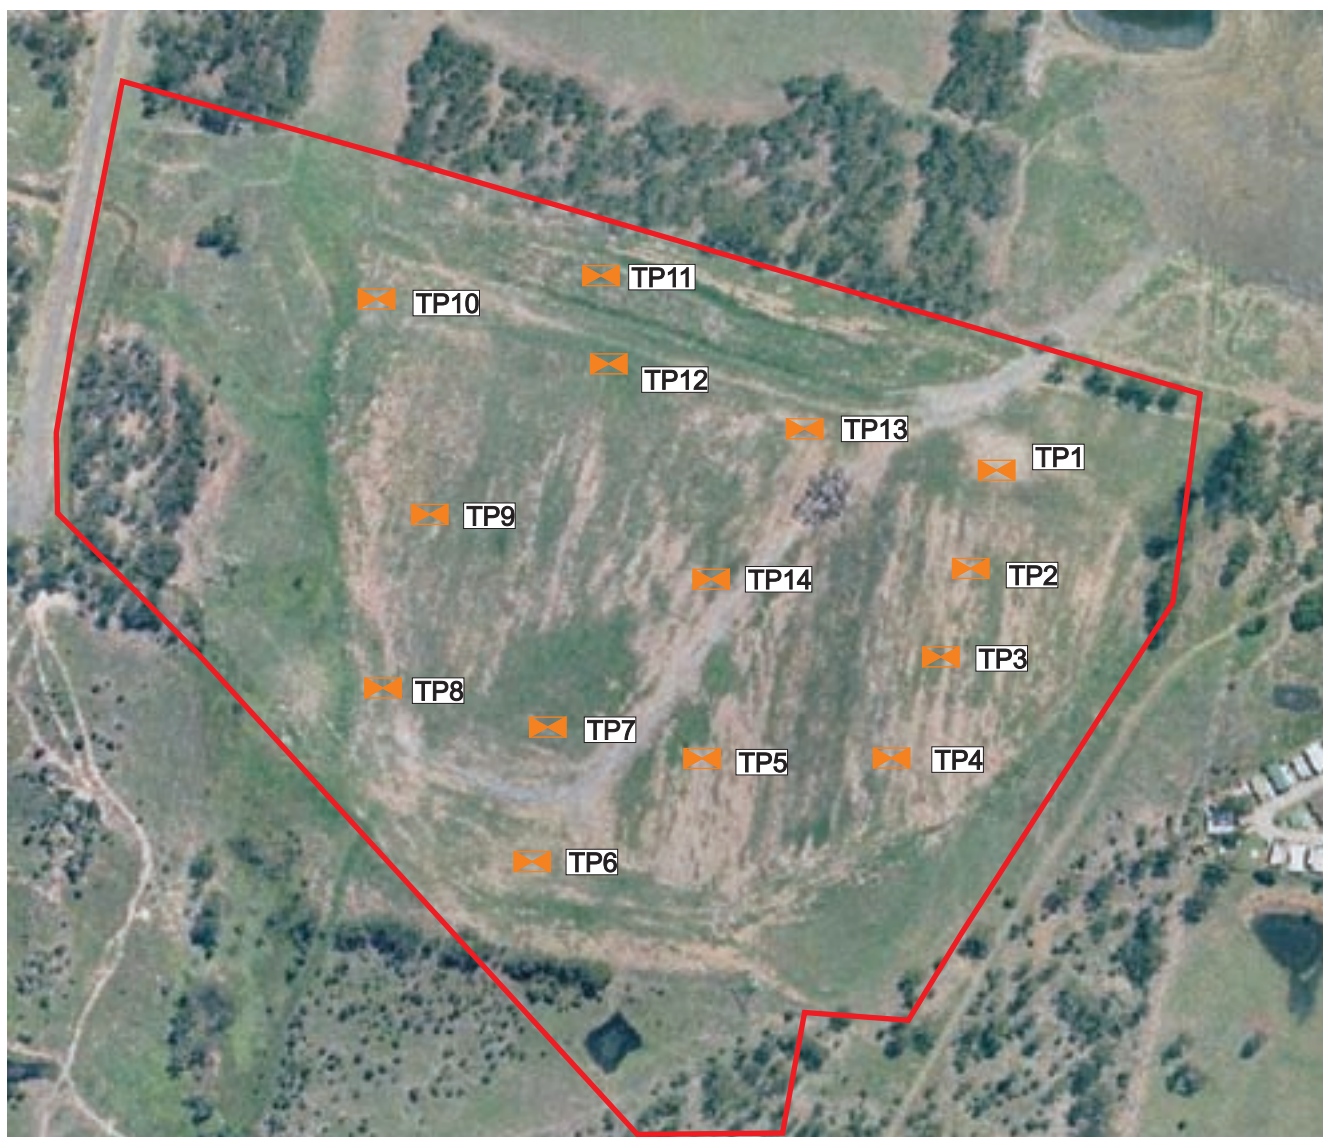
Figure 5a

Site Name/reference	Summary of ground conditions	
	Fill materials	Residual materials
<p>Landfill site, Figure 5a; TP15 to TP23 and BH1 to BH3</p>	<p>Fill materials encountered generally comprised light brown to dark brown sandy clay fill and light brown clayey sand fill. Mixed gravels and occasional cobbles were present</p> <p>Test pits 17 and 18, which were located in the present day crushing area, encountered grey gravelly fill material. TP17 encountered water and possible pond base sediments at 1.0m depth</p> <p>Test pit 23, which was located in the skip store area encountered grey sandy gravel. Significant waste materials were encountered in TP22 and 23 in this area, including glass, plastic, brick, tile, wood and fragments of possible asbestos containing cement sheet.</p>	<p>Residual materials were encountered in all test pits with the exception of TP18, which met refusal at 2.1m depth in hard rock boulders (fill/quarry spoil). Residual materials were encountered at a minimum depth of 0.6m in TP15 and at a maximum depth of greater than 2.1m in TP18.</p> <p>Residual materials comprised grey clay/weathered shale. Clays had orange and red mottling and were sandy in some locations. Fragments of grey weathered shale were common.</p>

Areas of Lot 47 of DP 262886 and Lot 292 of DP 1076555 not currently landfilled – area referred to as landfill site	Landfill and quarry activities were believed likely to have affected the areas adjacent the landfill cells.	Additional soil investigations undertaken around the periphery of the landfill cells indicated fill material to a maximum depth of greater than 2.1m. Glass, wood, metal and possible asbestos containing materials were noted in TP22 and TP23. Levels of contamination were below the applicable HIL(F) values. Some exceedence of the PBILs were noted.	The suitability (or otherwise) of this area for redevelopment will require some further assessment, including after the capping of the adjacent landfill. In particular: » Some remedial work may be required to remove potential asbestos containing materials; » The capping of the landfill site may encourage lateral migration of landfill gas, this will need further consideration; and » Any open space areas may require “capping” to preclude potential exposure to fill containing building rubble.	3

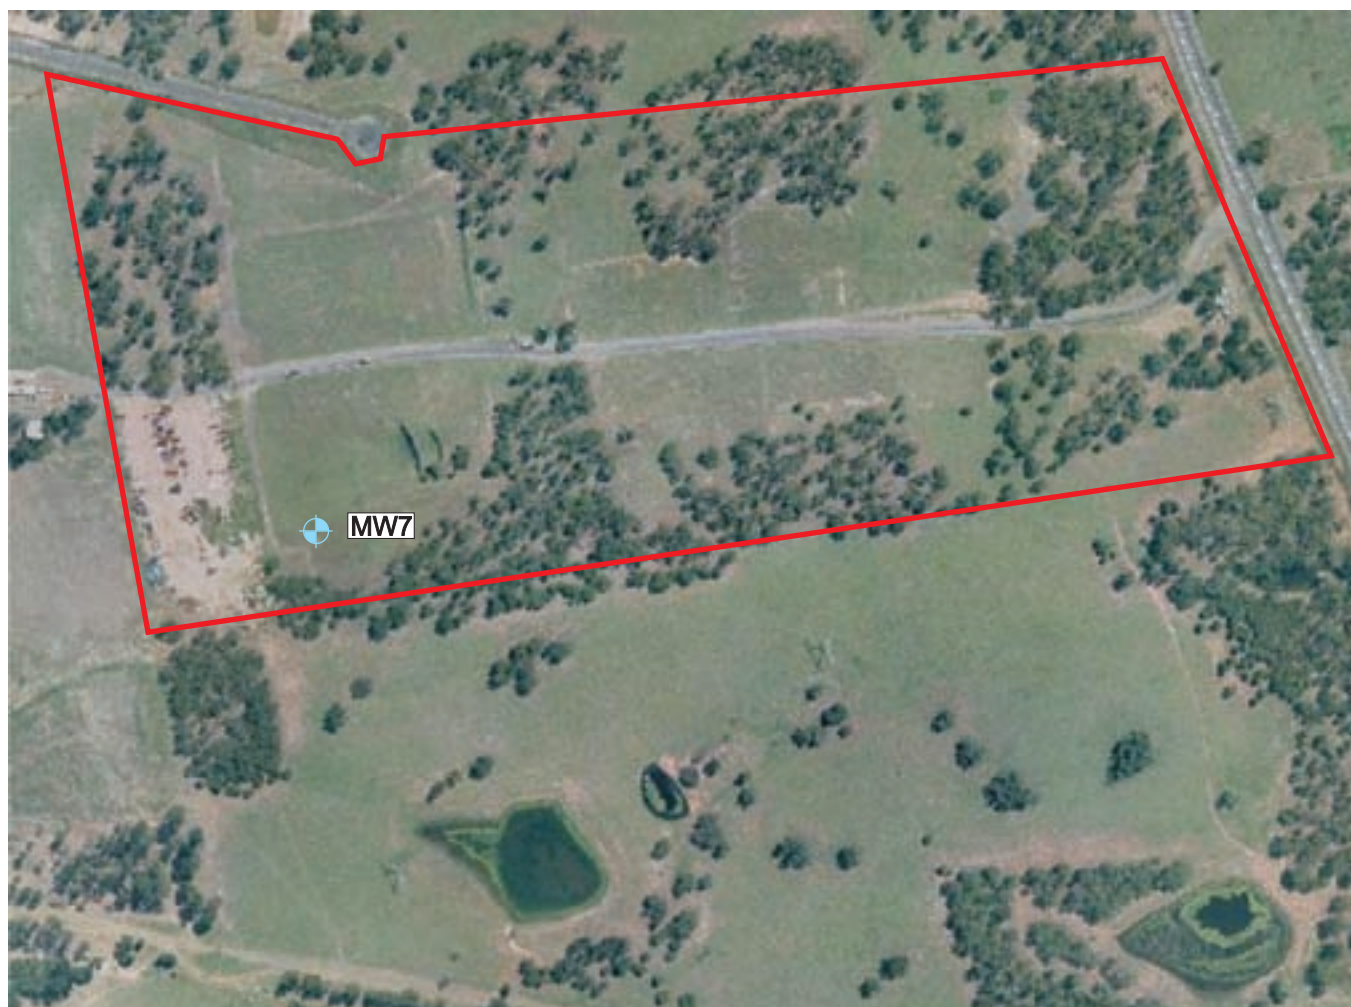
Figure 5b

<p>Paddock, Figure 5b; TP1 to TP14</p>	<p>Fill materials encountered comprised brown sandy clay underlain by grey clay with red or orange/tan mottling. Various gravels and occasional boulders and cobbles were noted.</p> <p>In test pits 7, 8, 9, 10, 12, 13 and 14, topsoil was underlain by a grey sandy clay fill with significant gravels, cobbles and occasional boulders –likely spoil from the former quarry adjacent.</p> <p>A relic soil layer (the former topsoil layer that would have been present prior to filling activities) was noted in most test pits at approximately 1m depth, occasionally waste materials including plastic, glass and metal were noted associated with this layer. There were no obvious indications of nightsoil deposits.</p>	<p>Residual materials were encountered in the majority of test pits with the exception of TP9 and 14 which met refusal in cobbles and boulders at 2.6m depth. Residual materials were encountered at a minimum depth of 0.9m in TP6.</p> <p>Residual materials comprised firm-stiff grey clays with red or orange/tan mottling with the exception of TP6 where a hard red rock was encountered at 1.0m depth.</p>

Lot 36 of DP 262886 and part of Lot 35 of DP 262886 – area referred to as “Paddock”	The ‘paddock’ area was believed to have been used for the disposal of nightsoil materials. Overburden from the landfill site had also been deposited across the area.	Soil investigations indicated fill material across the site to maximum depths of greater than 2.6m. Fill material was generally re-worked clay material or shale spoil from quarrying activities. No evidence of nightsoil was noted. Occasional plastic and metal was noted in fill material. Levels of contamination were below the applicable HIL(F) values. Some exceedence of the PBILs were noted.	The paddock area appears suitable (from a contamination perspective) for industrial/commercial development.	2
Lot 291 of DP 1076555 including proposed Integral Energy site	Phase 1 contamination assessment reported under separate cover (GHD report ref. 2117717/143416, August 2008)	Area investigated and reported under separate cover (GHD report ref. 2117717/145262, November 2008)	The area appears suitable for commercial /industrial development.	1

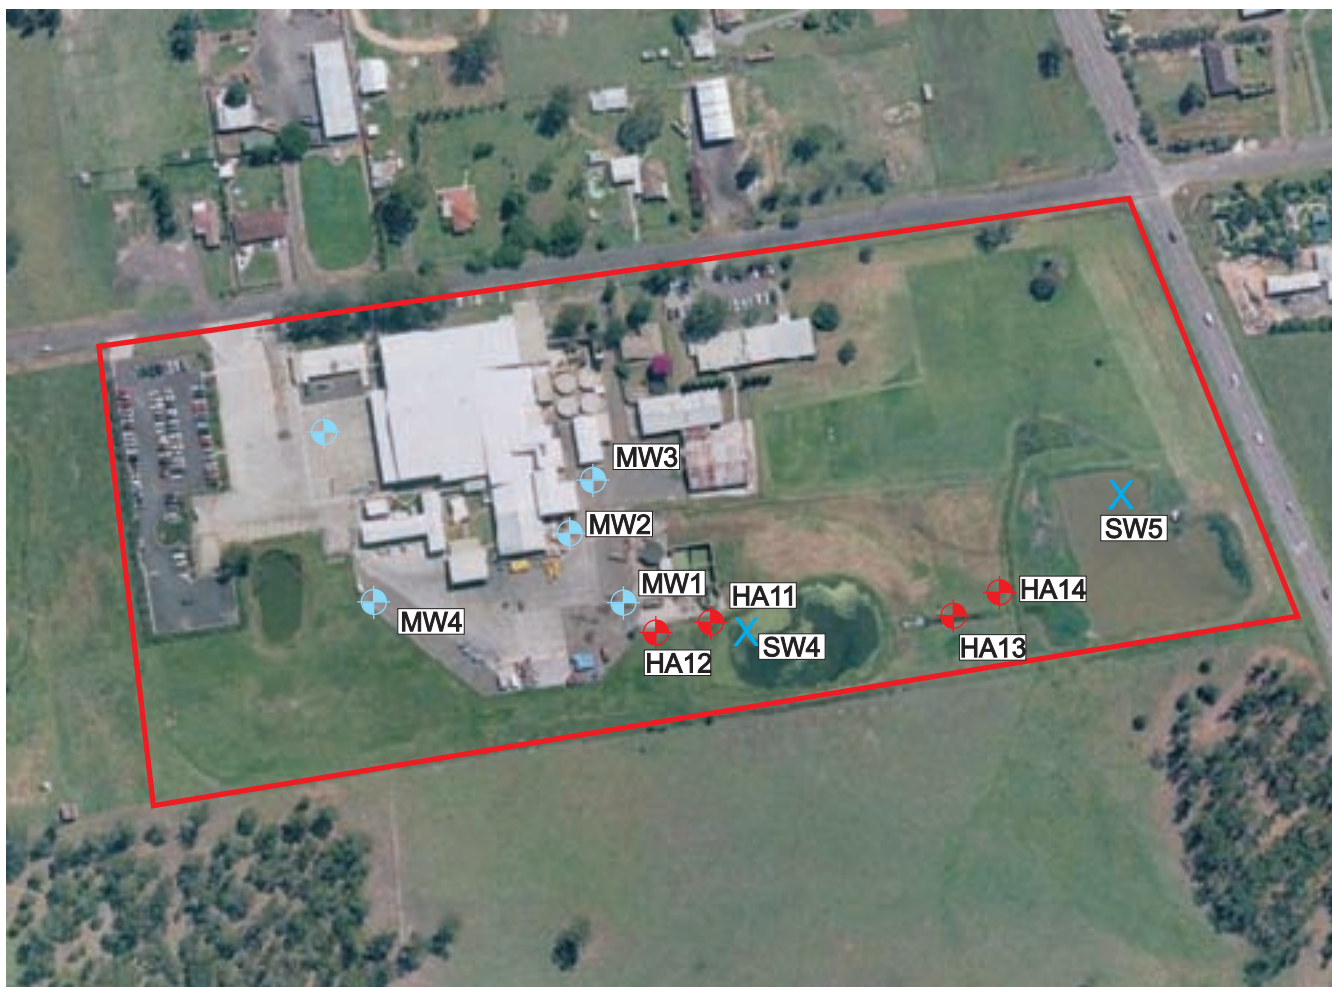
Figure 5c

Site Name/reference	Summary of ground conditions	
	Fill materials	Residual materials
<p>Former Sanitary Depot, Figure 5c; MW7</p>	<p>Brown clayey sand with a layer of brown/black fibrous organic matter (likely nightsoil) was noted at surface. An organic odour was noted and pieces of plastic were present. Fill materials extended to 1.0m.</p> <p>Re-worked natural materials comprising grey clay with orange and red mottling was present underlying the fill materials to depths of approximately 2.0m.</p>	<p>Residual materials comprised grey clay with red and brown highly weathered shale fragments.</p>
<p>Steggles Chicken Factory Figure 5d; HA11 to HA14 and MW1 to MW4</p>	<p>HA11 to HA14 were located in grassed areas, MW1 to MW4 were located in concrete or gravel road areas.</p> <p>Fill materials generally comprised brown sandy clays with various gravels, including road base gravels in MW 1, 3 and 4.</p> <p>HA13 was located in a drain area and encountered moist, grey drain sediments with high organic matter.</p> <p>No significant waste materials, odours or staining that might indicate contamination were noted.</p> <p>Some re-worked natural materials were encountered; these generally comprised grey and red or orange stiff clays.</p>	<p>Residual materials were encountered in HA 13 and MW1 to MW4 commencing at a minimum depth of 0.3m in HA 13 and at a maximum depth of 2.0m in MW3 and MW4.</p> <p>Residual materials generally comprised grey clays with red or orange/tan mottling, grading to weathered brown, tan or grey shales. Shale fragments in drill returns tended to be brittle and weak, however hard drilling was encountered in shale materials.</p>

Lots 11 and 12 of DP 262886 – former Council Sanitary Depot	Previous site investigation reports by URS (2002 to 2005) indicated that the area will require remediation to enable development. Further groundwater monitoring was recommended (by GHD) to update the existing data.	A groundwater monitoring well was installed in the south west corner of the area where industrial waste had been deposited. Concentrations of heavy metals in groundwater were reported slightly in excess of the ANZECC guidelines. Concentrations of TPH, BTEX, PAH and VOCs were below the laboratory PQL.	Groundwater contamination should not constrain industrial/commercial development of the area. Recommendations made by URS regarding remediation of soil contamination are still relevant.	4
Lot 1 of DP 747184 – Steggles Chicken Factory	Potential contamination issues were highlighted associated with the storage of fuels, the water treatment plant and surface waters.	Soil, surface water and groundwater investigations were undertaken. Fill materials were noted to maximum depths of 2.0m, fill materials were generally road base materials or re-worked natural materials. Concentrations of TPH C ₁₀ -C ₃₆ in MW1 and MW3 were elevated over the site assessment criteria, concentrations of B(a)P in MW4 were equal to the HIL(A).	It is apparent that soil, surface water and groundwater on the Steggles site is subject to some (limited) impact, most notably by ammonia and/or biological contaminants. The Steggles site is considered likely to be able to be made suitable for commercial or industrial development, subject to the following recommendations: » Further consideration should be given to the water quality in SW4, water quality treatment may be required if the dam is to be drained to another site or incorporated into	3
