Part 2:

Practical guidance

Part 2 of the Haydon Park Investigation Study provides practical guidance on how to incorporate tree canopy cover within stormwater basins. It is intended to be used as a reference guide for anyone introducing tree canopy cover into dual-purpose open spaces that have a stormwater infrastructure function.

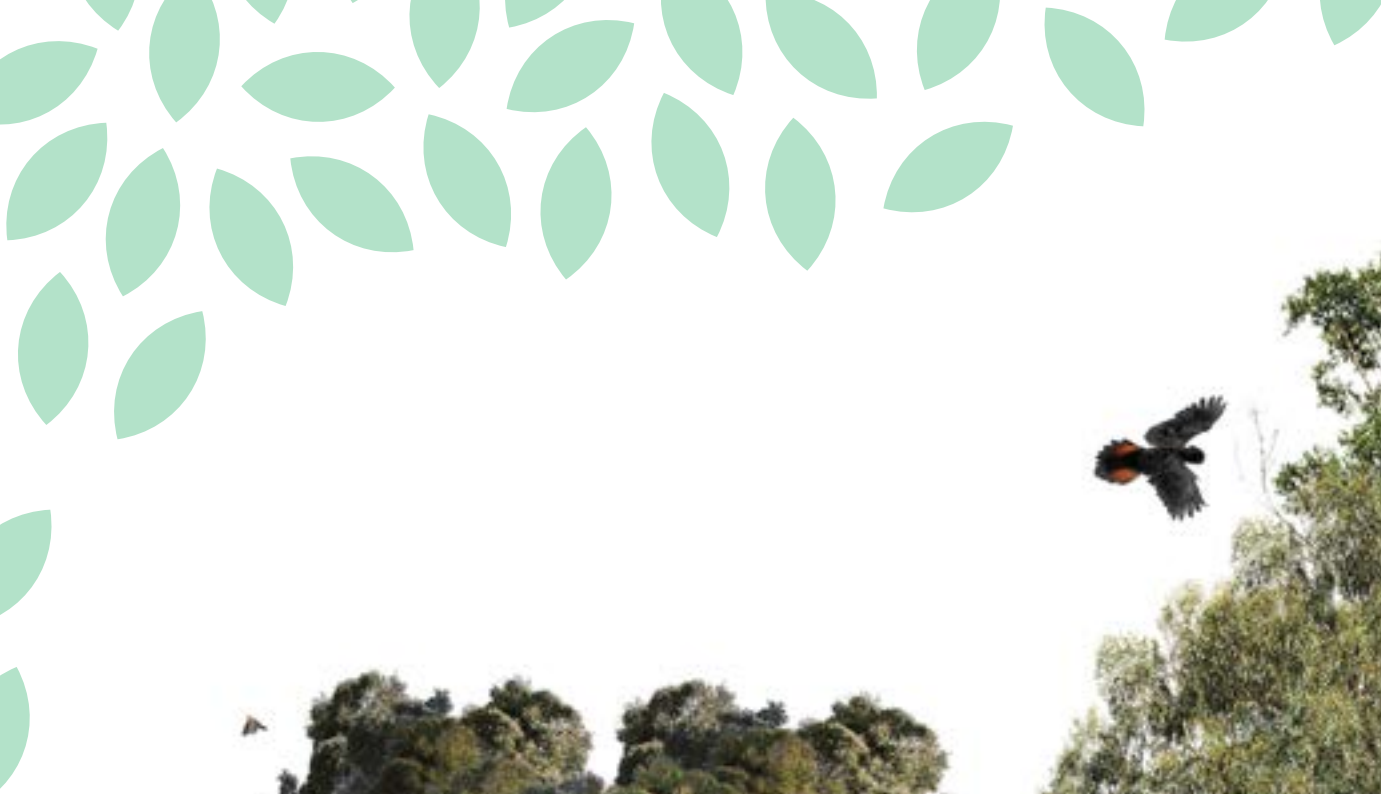
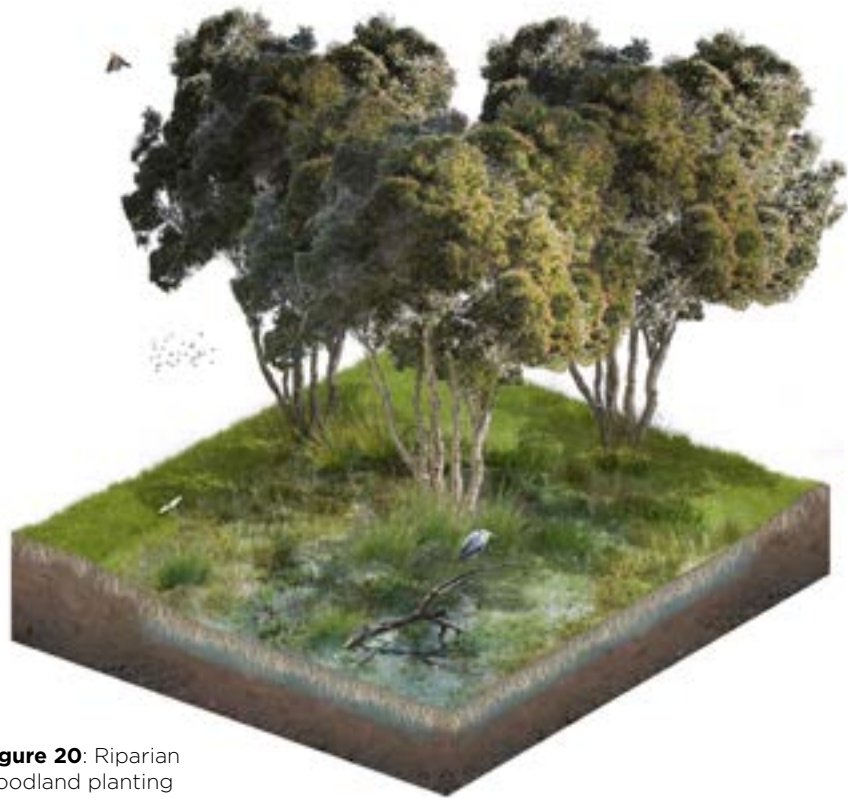
Figure 20: Riparian woodland planting

The tree palette aims to represent two significant biotopes found within the Cumberland Plains – Riparian Woodland and Plains Open Woodland. In nature, these woodlands are separated based on soil type and water availability. The tree species have been selected for the specific growing conditions. This will improve tree health, potential tree canopy cover and increase tree life expectancy. This separation will also help to identify the presence of water. People will experience the division between a wet and dry landscape via the colours, shapes and sizes of the trees.

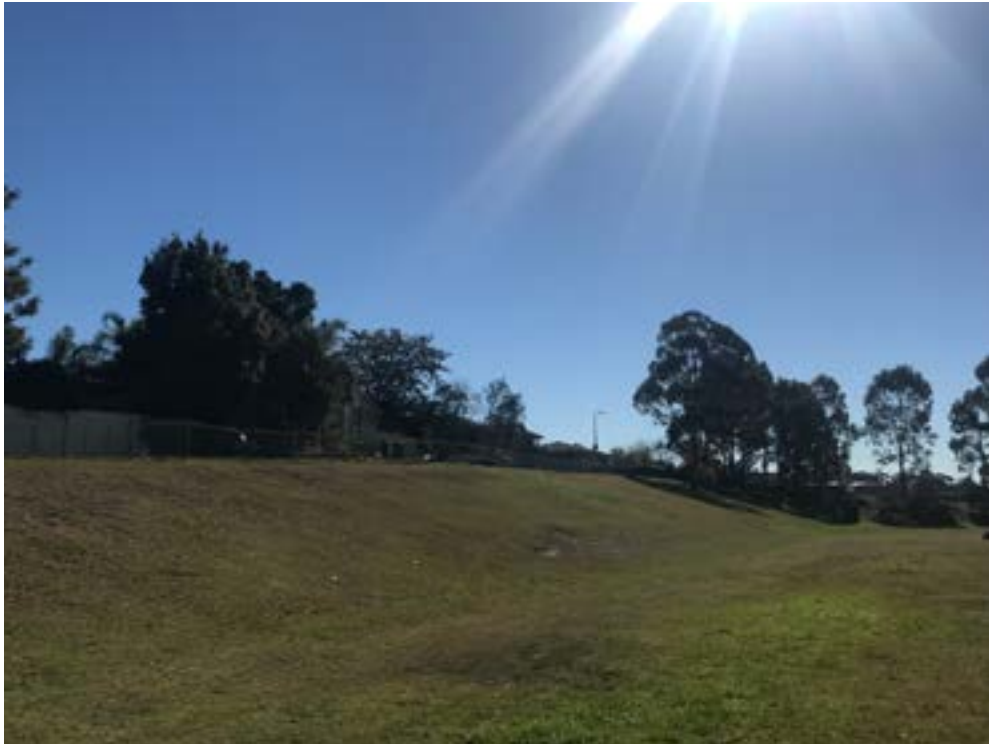
Figure 26: Photograph of the existing Haydon Park cut embankment

Regular geotechnical inspections of the basin embankments are necessary to check the structural integrity of the wall. For these inspections to occur, most councils prefer short mowed grass to other vegetation types on embankments, allowing cracks and other geotechnical defects to be easily observed and measured during inspections. The New South Wales Dam Safety Committee recommends embankments 'should be protected by a uniform, robust, grass cover that can be routinely mowed'. Trees can, however, be freely planted within the floor of the basin and on slopes cut into the surrounding landscape.

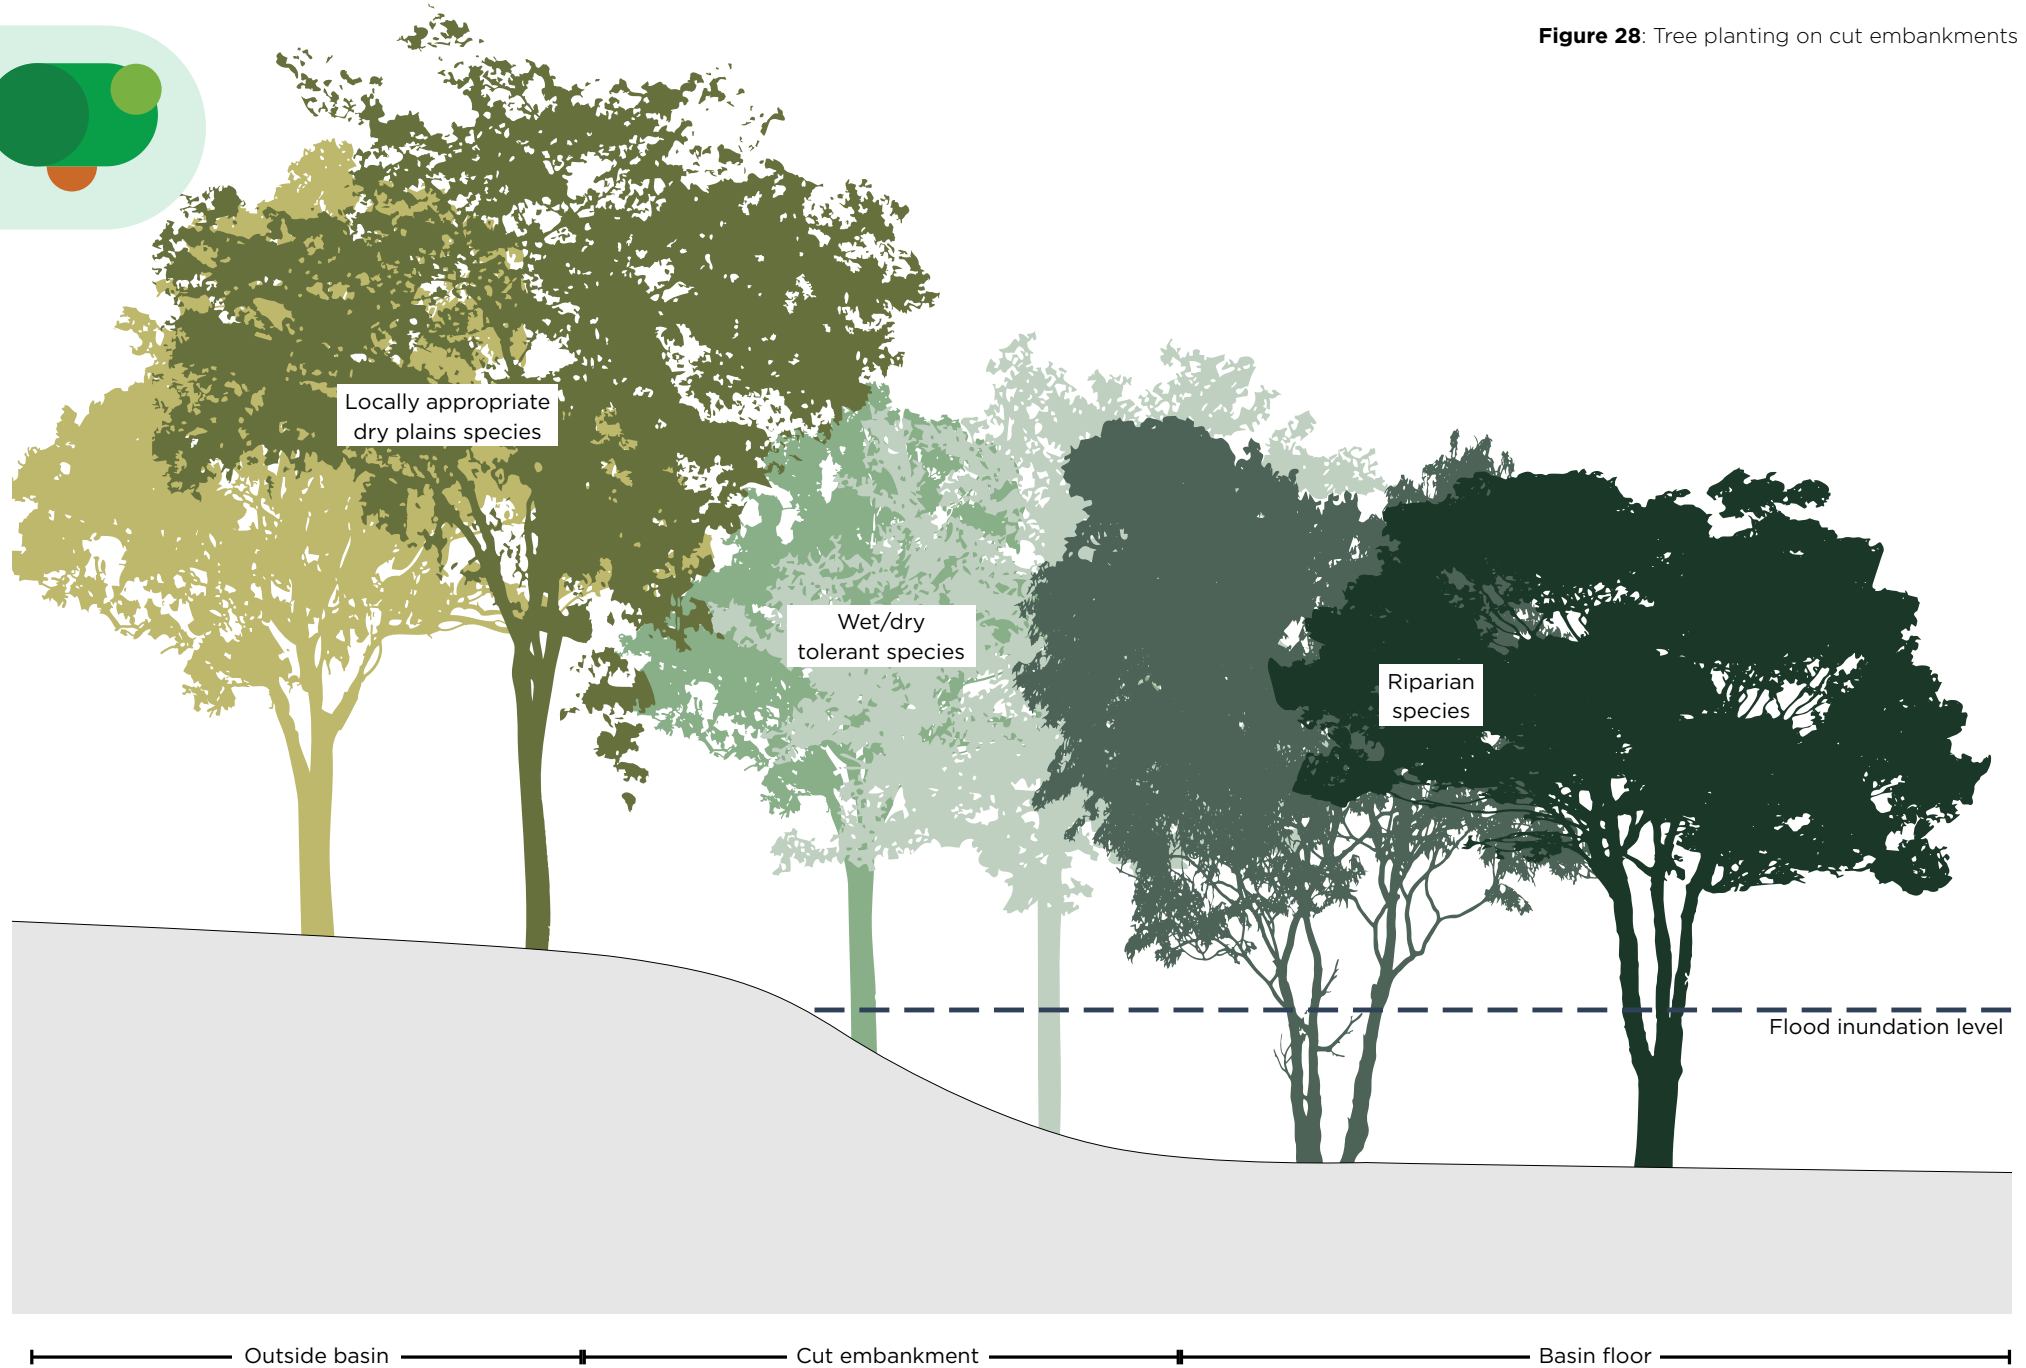
Figure 28: Tree planting on cut embankments

Flood-retarding basin location	Trees	Species selection
Basin floor (min. 3m clear of fill and outlet structures)	✓	Tolerant of both saturated soil conditions and dry spells. Where planting within dedicated frequent flow paths or wet zones, opt for riparian species.
Fill embankment (dam walls)	✗	n/a
Cut embankments (slope areas in cut)	✓	Wet/dry tolerant species.

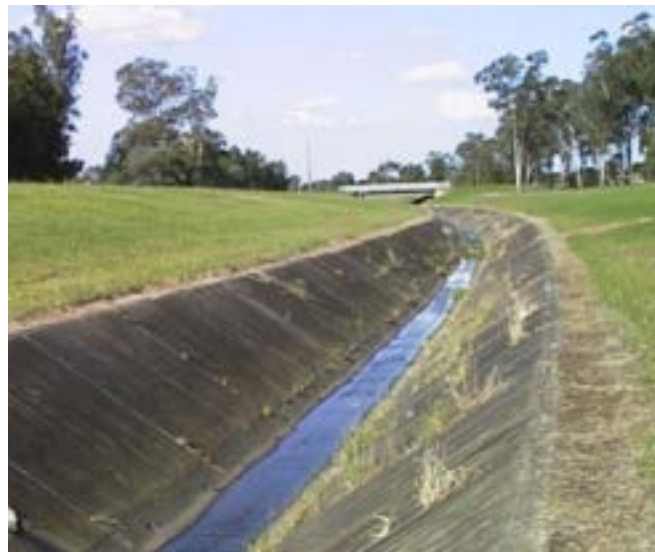
Figure 35: Clear Paddock Creek stormwater drain before works. *Source: E2 Design Lab*

Clear Paddock Creek was a concrete stormwater drain in Fairfield, New South Wales, that was restored to a beautiful living stream through a rich landscape in 2000. The project developed an urban landscape of biodiversity with clean, clear waters and a rich new habitat. In a 2011 review of the works, to see whether it still met creek naturalisation best practice at the time and to see where any design improvements could be identified, the works were proven to be 'outstandingly resilient, providing excellent visual amenity and biodiversity and to be consistent with current best practice'. The rehabilitated waterway now has vastly improved ecological value, using riparian planting, while still providing flood protection for the local community.

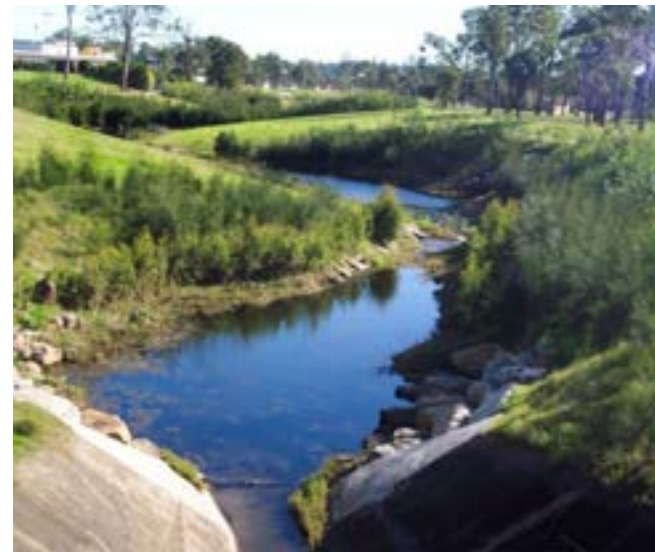
Figure 36: Clear Paddock Creek after restoration (2001). *Source: E2 Design Lab*

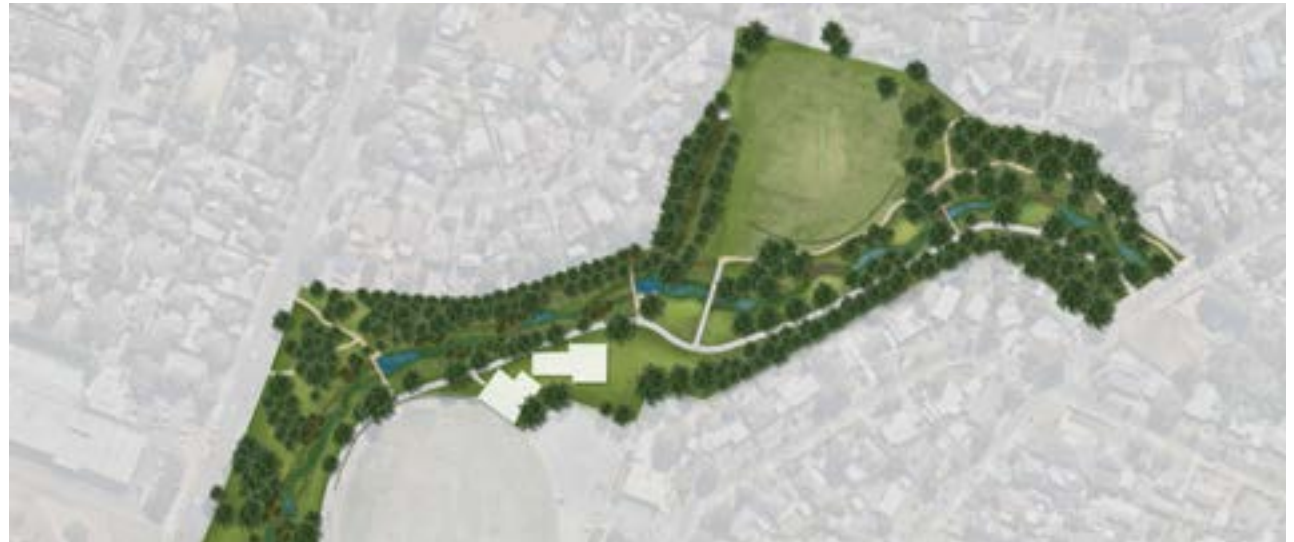
Figure 43: Concept plan for Blind Creek renaturalization project. *Source: Realm Studios.*

Blind Creek was a piped low-flow system, much like Haydon Park. Daylighting the stormwater was seen as a way to reconnect the waterway with the community by bringing the water to the surface. Additionally, creek flows are captured, cleansed and stored for irrigation of nearby sports ovals and native vegetation.
